FINAL REPORT - CONTRACT DAAG46-70-C-0043

AMMRC CR 70-20

DETERMINATION OF FLAWS IN AN 81 MILLIMETER PROJECTILE BODY USING THE
TRW ACOUSTO-OPTICAL IMAGING DEVICE

Final Report - Contract DAAG46-70+C-0043

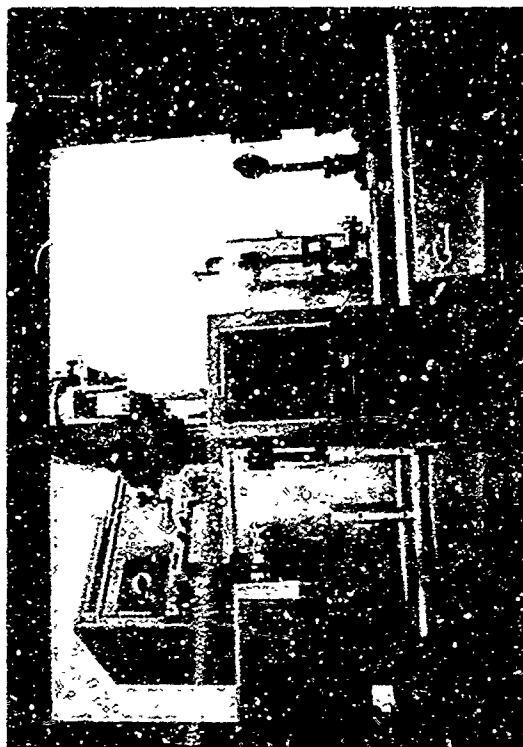
Figure 10 Relationship between the optical axis, acoustic crystal and shell segment.

(a) Shell segment held out of the Bragg Cell.

(b) Shell segment held inside the Bragg Cell.

A special fixture was designed and built to handle the shell in the Bragg Cell of the Acousto-Optical Imaging device. The fixture has the capability of translating and rotating the shell in the Bragg Cell. Figures 10(a) and (b) show one segment of the shell held by the fixture outside and inside of the Bragg Cell, respectively. The capability to both rotate and translate the shell is necessary so that the entire shell case can be conveniently inspected.
